Contract #: 04-0120F4Cty: SF/ALA Rte: 80 PM: 13.2/13.9File #: 69.28**WELDING INSPECTION REPORT****Resident Engineer:** Siegenthaler, Peter**Address:** 333 Burma Road**City:** Oakland, CA 94607**Report No:** WIR-016948**Date Inspected:** 07-Sep-2010**Project Name:** SAS Superstructure**OSM Arrival Time:** 700**Prime Contractor:** American Bridge/Fluor Enterprises, a JV**OSM Departure Time:** 1900**Contractor:** Zhenhua Port Machinery Company, Ltd (ZPMC), Changxing Island **Location:** Shanghai, China**CWI Name:** Qiu Wen**CWI Present:** Yes No**Inspected CWI report:** Yes No N/A**Rod Oven in Use:** Yes No N/A**Electrode to specification:** Yes No N/A**Weld Procedures Followed:** Yes No N/A**Qualified Welders:** Yes No N/A**Verified Joint Fit-up:** Yes No N/A**Approved Drawings:** Yes No N/A**Approved WPS:** Yes No N/A**Delayed / Cancelled:** Yes No N/A**Bridge No:** 34-0006**Component:** Tower & OBG Components**Summary of Items Observed:**

LIFT-5 SOUTH TOWER GRILLAGE

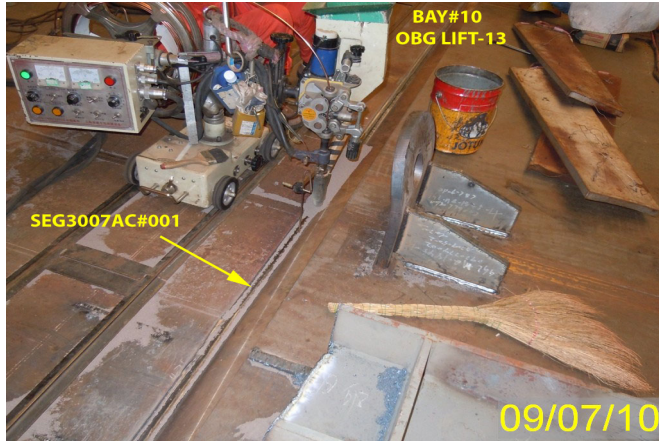
Weld joint # 01 located on SEG3007AC (BP3032+BP3033). Welder is identified as 044780. ZPMC Quality Control (QC) Inspector is identified as Zhong Guo Hui. The welding variables recorded by QC appeared to comply with the WPS – B – T – 2221 – B – U3c – S – 2. (See attached photo)

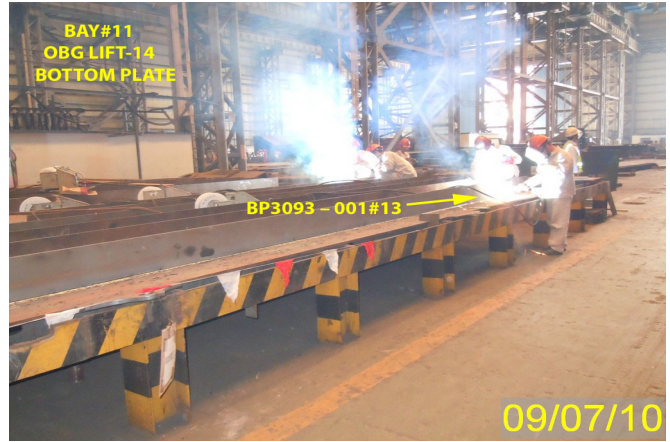
Weld joint # 13 located on Bottom plate BP3093 – 001. Welder is identified as 049220. ZPMC Quality Control (QC) Inspector is identified as Liu Dao Feng. The welding variables recorded by QC appeared to comply with the WPS – B – T – 2132. (See attached photo)
